VINGT-CINQUIÈME CONGRÈS
DES GRANDS BARRAGES
Stavanger, Juin 2015

**THE UNIFIED PLOT APPROACH FOR ASSESSING INTERNAL EROSION – A
CASE STUDY OF THE GRUNDSJÖN DAM SINKHOLE EVENT (*)**

This paper describes the unified plot approach for assessing internal erosion susceptibility of existing dams. Thereafter, it reports a case study of the Swedish Grundsjön dam and an evaluation of its sinkhole event in 1990 using the unified plot approach.

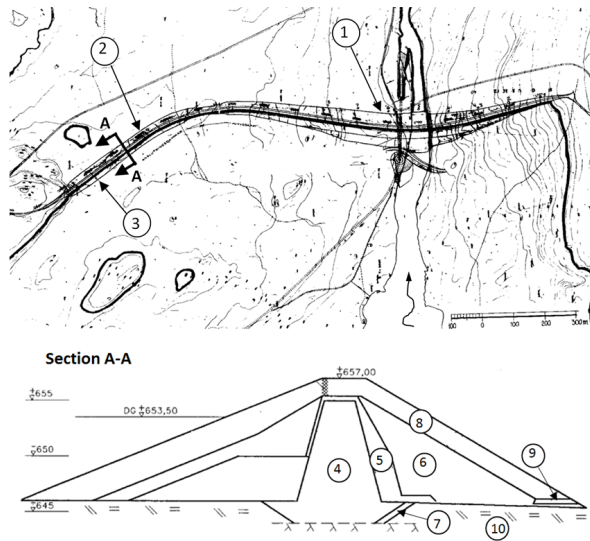
Fig. 2

In September 1990, 18 years after commissioning, a crater-like depression was discovered on the upstream edge of the crest of the Grundsjön Connecting dam (Fig. 2). The depression measured 0.4 x 0.5 m on the surface, and closer examination revealed it to extend approximately 1.6 m vertically into the dam body. It was aligned with the upstream face of the core, and thus possibly a sinkhole due to internal erosion [11]. In a first phase of examination in the fall of 1990, immediately after the discovery of the sinkhole, the crest of the dam was removed exposing the crest of the core in the area of the sinkhole. Although these initial test pits revealed relatively little about the extent of the damage, the exploratory penetration tests conducted from the crest of the core, as well as falling-head tests carried out in the piezometers, provided more information; the core soil was loose locally and exhibited a high take of water during the infiltration tests. Furthermore, the piezometric readings from the standpipes in the core showed pore pressure levels higher than theoretically expected. These findings indicated that the core was, indeed, damaged, possibly by internal erosion, but additional investigations were needed to clarify the cause of the sinkhole and to ensure a safe resumed operation of the reservoir. Thus, a second phase of examination was undertaken in the spring of 1991 which involved a complete uncovering of the core and filter over a length of 60 m. Excavation was carried out in stages of 1 m lifts and at the lowest it reached down to +644m, 13 m below the dam crest, completely exposing the filter and core (Fig. 3). Visual observations are shown in Fig. 3. Several signs believed indicative of internal

The Grundsjön dam (in plan view) and connecting dam (in cross-section)
Le barrage de Grundsjön (vue en plan) et le barrage de liaison (vue en coupe)

| 3) Sinkhole location | 3) <i>Emplacement du trou d'affaissement</i> |

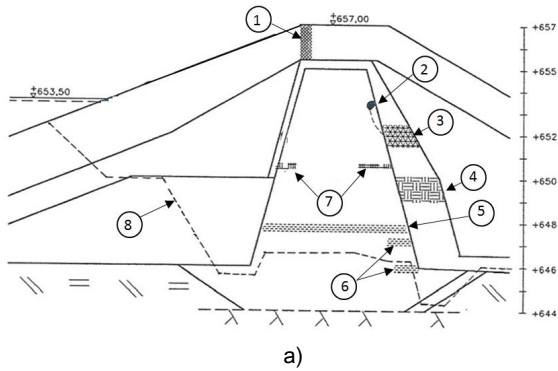
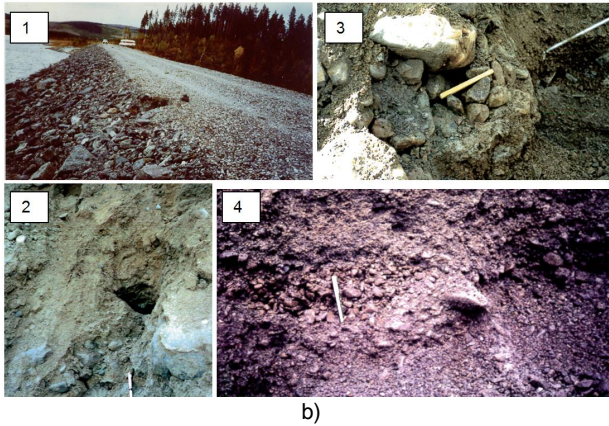
Fig. 3

erosion were observed, most notably the actual sinkhole, cavities in the core, wet zones, core soils devoid of fines and the presence of a leakage path through the core (observation 5, Fig. 3). Furthermore, there were observations indicative of the continuation of erosion, e.g., filters washed out of fines (Fig. 3) as well as probable contributing causes to the process (pockets of coarse filter of cobbles possibly a consequence of segregation during placement). The dam was carefully rebuilt in 1991, and was provided with an improved drainage system as well as the implementation of an extensive monitoring program of instrumentation [11, 12].

The excavation of the core in 1991 of the Grundsjön dam with a) observations and b) photo evidence (adapted after [11, 12])
Excavation du noyau du barrage de Grundsjön en 1991 avec a) observations et b) preuves photographiques (selon [11, 12])

| 1) Sinkhole | 1) Trou d'affaissement |
| 2) Large cavity in the core | 2) Grande cavité dans le noyau |
| 3) Fines washed out of filter with evidence of core fines in fill, and pockets of cobbles | 3) Matériaux fins du filtre lessivés avec présence de matériaux fins du noyau dans le remblai, et galets |
| 4) Fines washed out of filter | 4) Matériaux fins du filtre lessivés |
| 5) Fines washed out of core and leakage path | 5) Matériaux fins du noyau lessivés et chemins d'infiltration |
| 6) Wet zones | 6) Zones humides |
| 7) Small cavities in the core | 7) Petites cavités dans le noyau |

There are no records as to whether larger D_{max} were permitted in the filter, and although the specifications stipulated 50 mm, forensic photo evidence indicates that coarser fractions than this were used (Fig. 3).

The Grundsjön dam was carefully rebuilt in 1991 and was provided with an improved drainage system as well as the implementation of an extensive monitoring program of instrumentation, and has since operated satisfactorily.

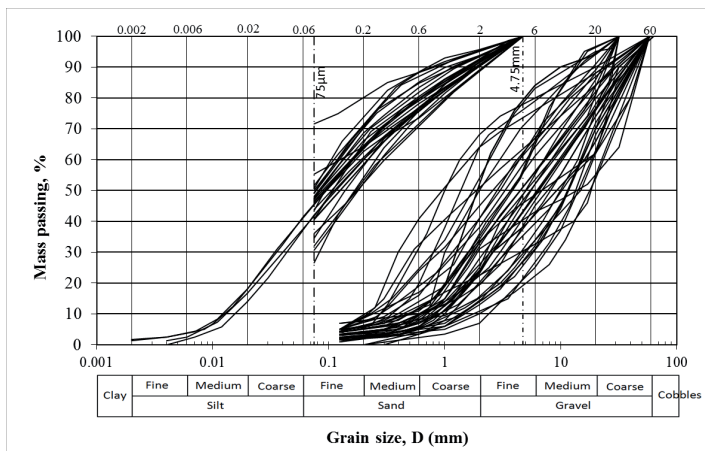
Fig. 4

Envelope of core gradations (< 4.75 mm) and as-placed filter gradations of the Grundsjön dam

The gradations of the core and filter gradations are presented in Fig. 4. They comprise 43 filter gradations and 27 core gradations taken from construction records [11]. The core soil is a glacial till and when regraded on the #4 sieve (i.e., 4.75 mm), as shown in Fig. 4, it has about 30 to 50 % < 0.075 mm (i.e., fines content); less than 2 % < 0.002 mm (i.e., clay-size); and a d_{85} of 0.3 to 1.0 mm. The filter is a sandy gravel with $0.3 \leq D_{15} \leq 3.5$ mm and $D_{max} = 64$ mm.

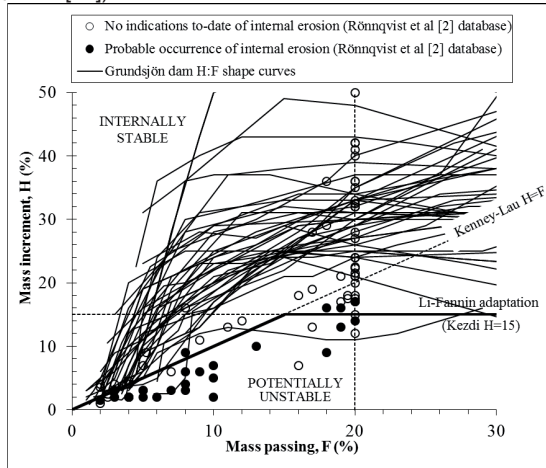
Applying the Kenney and Lau criterion [3, 4], and the Li and Fannin adaptation [5], Fig. 5 shows the H:F shape curves for the 43 filter gradations. Extracting the stability index $((H/F)_{min})$ from the H:F shape curves, i.e., the smallest value of H/F in the evaluation range $0 < F \leq 20\%$, reveals that 16 of the 43 gradations (37 %) are potentially unstable (i.e., $(H/F)_{min} < 1$) with a lowest stability index $(H/F)_{min}$ of 0.43. Many of the gradations are unstable on their finer end (Fig. 6). The Grundsjön dam data for all 43 filter gradations are thus superimposed over the Rönnqvist et al [2] database which comprises the single-most vulnerable data point for each dam. Similarly, the method of Wan and Fell [7], which evaluates internal instability from a characteristic value for the slope of the coarser fraction (D_{90}/D_{60}) and the overall slope of the gradation curve (D_{90}/D_{15}), establishes that 18 of the gradations are unstable, with the highest probability of 90 % for one gradation (Fig. 7). The Foster and Fell filter boundaries [9] analysis shows, moreover, that the dam-specific NE boundary is 0.7 mm for the Grundsjön dam (i.e., Group 2A base soil for which the fines content is 35 to 85 % of base soil passing the No. 4 (4.75 mm) sieve), the EE boundary is approximately 4.5 mm and the CE boundary is 18 mm (i.e., $D_{15} > 9 d_{95}$ after [14]).

H:F shape curves of Grundsjön dam filter gradations superimposed over Rönnqvist *et al* [2] database
Courbes H:F de granulométrie du filtre du barrage de Grundsjön superposées à la base de données Rönnqvist et al [2]

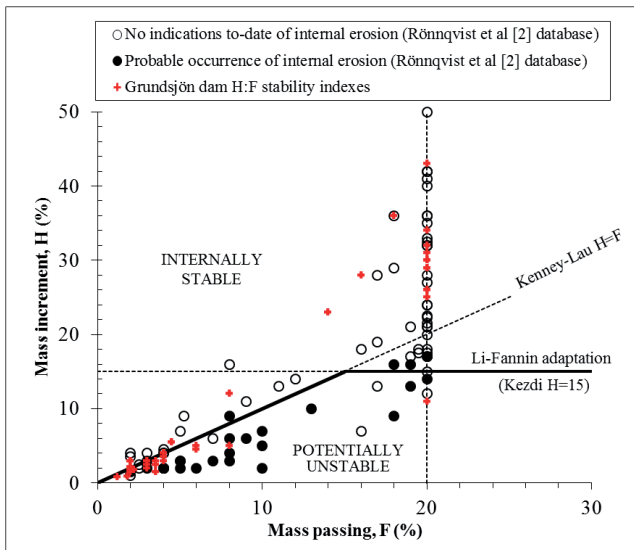
Fig. 6

Stability indexes of Grundsjön dam filter gradations superimposed over Rönqvist *et al*[2] database
Indices de stabilité des types de granulométrie du filtre du barrage de Grundsjön superposés à la base de données Rönqvist et al [2]

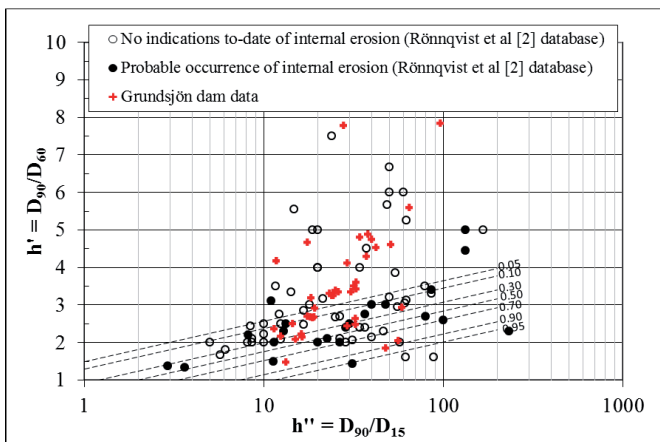
Fig. 7

Probability of internal instability of the filter gradations of the Grundsjön dam superimposed over Rönqvist *et al*[2] database
Probabilité d'instabilité interne des types de granulométrie du filtre du barrage de Grundsjön superposés à la base de données Rönqvist et al [2]

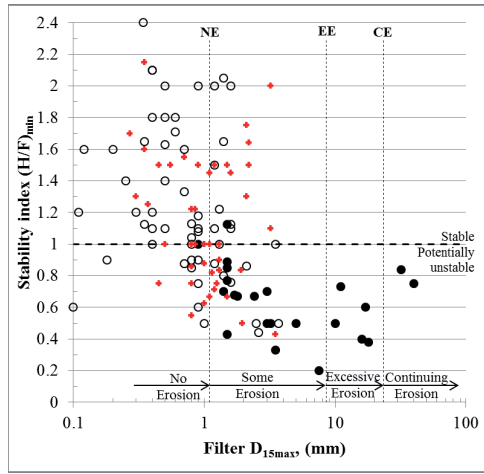
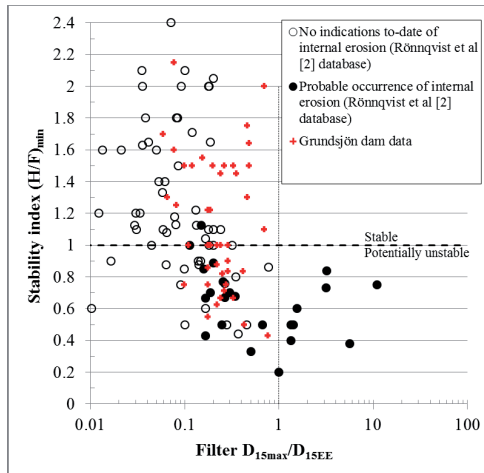
Fig. 8

Analysis of the unified plot (Fig. 8a) shows that a considerable number of gradations locate in the No Erosion and internally stable zone, but there are gradations on the coarser end of the envelope that clearly plot in the Some erosion and internally unstable zone. This zone is where many dams with probable occurrence of internal erosion are found to plot. In the dimensionless unified plot (Fig. 8b), on a dam-specific basis, the data of the Grundsjön dam are plotted in relation to its EE boundary of 4.5 mm: the majority of gradations plot in the Some erosion zone (which is located in the range between the NE and EE boundaries), which according to the method of Foster and Fell [9] would make it equally likely that the filter will seal with Some erosion as with Large erosion in the case of a concentrated leak through the core.

Unified plot approach with data points from the analysis of Grundsjön dam superimposed over Rönnqvist *et al* [2] data base
Approche par scénario avec des points à partir de l'analyse du barrage de Grundsjön superposée à la base de données Rönnqvist et al [2]

| a) Unified plot with average values of NE, EE and CE. | a) <i>Scénario avec les valeurs moyennes de NE, EE et CE.</i> |
| b) Dimensionless unified plot for D_{15max}/D_{15EE} | b) <i>Scénario adimensionnel pour D_{15max}/D_{15EE}</i> |

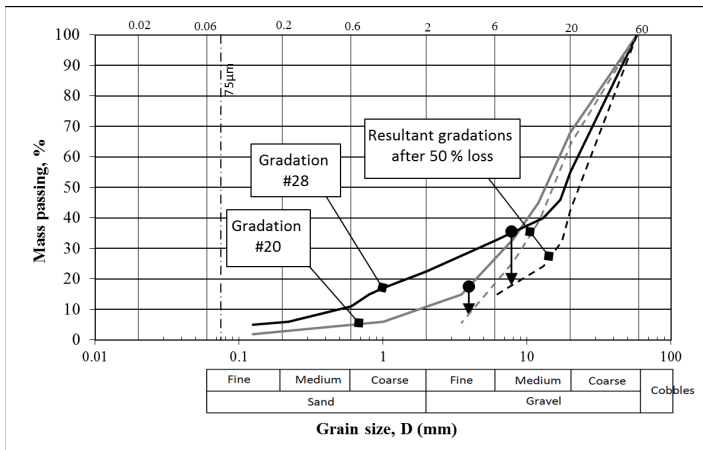
Fig. 9

Taking the ICOLD [1] and Wan and Fell [8] approach into account, in terms of finer fraction and its loss through the action of suffusion, the resultant gradation for two construction gradations (i.e., #20 and #28) deemed representative of the Grundsjön dam are shown in Fig. 9. Accordingly, assuming a 50 % loss of the finer fraction yields an effective D_{15} of approximately 6 mm, and the conservative approach of assuming a 100 % loss yields a D_{15} of 7 to 18 mm. Considering the dam-specific EE boundary of 4.5 mm the two selected construction gradations would exceed it. In support, forensic photo evidence (Fig. 3) indicates that the filter was indeed washed out (suffused).

Selected filter gradations of the Grundsjön dam that are potentially unstable and corresponding filter assuming a 50 % loss of finer fraction
Granulométries sélectionnées du barrage de Grundsjön potentiellement instables et filtre correspondant supposant une perte de 50 % de la fraction la plus fine
