VINGT-CINQUIÈME CONGRÈS
DES GRANDS BARRAGES
Stavanger, Juin 2015

**THE UNIFIED PLOT APPROACH FOR ASSESSING INTERNAL EROSION – A
CASE STUDY OF THE GRUNDSJÖN DAM SINKHOLE EVENT (*)**

This paper describes the unified plot approach for assessing internal erosion susceptibility of existing dams. Thereafter, it reports a case study of the Swedish Grundsjön dam and an evaluation of its sinkhole event in 1990 using the unified plot approach.

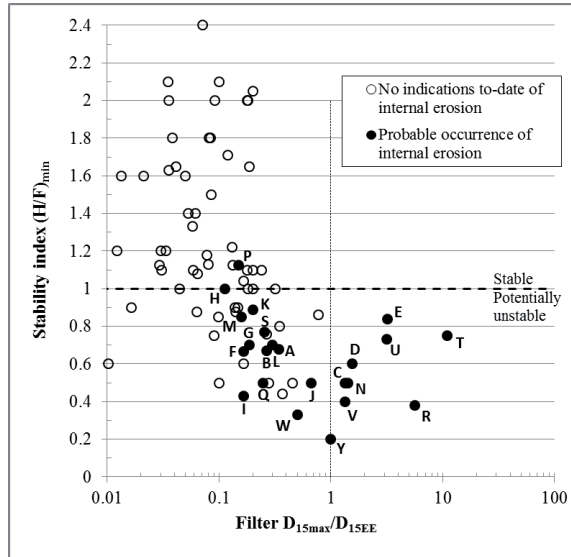
Fig. 1

Dimensionless unified plot of the relation between stability index of the filter gradation and dam-specific ratios for base soil retention D_{15max}/D_{15EE} [2]
Scénario adimensionnel de la relation entre l'indice de stabilité correspondant à la granulométrie du filtre et les coefficients - spécifiques aux barrages - de rétention du sol de base

retention by a filter (i.e., a No Erosion (NE) boundary, an Excessive Erosion (EE) boundary; and, a Continuing Erosion (CE) boundary) correlate well with the inferred probable occurrence of internal erosion (Fig. 1). The range between the NE and EE boundaries is termed, herein, the Some Erosion zone of base soil retention. By taking all the available gradation curves for the filter of the dams into account, gradation analysis established the most vulnerable gradation curve in terms of stability indices H/F_{\min} and $D_{15\max}$, yielding one data point per dam. Furthermore, the dimensionless plot is established by using the dam-specific EE boundary to calculate the ratio $D_{15\max}/D_{15EE}$ (Fig. 1). Thus, combining the stability index $(H/F)_{\min} < 1$ of Kenney and Lau [3, 4] with the soil retention capacity of a filter (by using the filter boundaries proposed by Foster and Fell [9]), yields a significant improvement in the identification of dams that exhibit deficiencies from internal erosion, and thereby encourages use of the unified plot (Fig. 1) as a screening tool for internal erosion susceptibility in engineering practice. The dam denoted by “J” in Rönqvist et al [2], as illustrated in Fig. 1, is the most vulnerable data point for the Grundsjön dam, which will be studied in detail in the following.
